# *Use of Electrosark Deposition for Repair of Navy Components*

March 2005 HCAT Meeting  
Greensboro, NC

**NSWC Carderock Division**

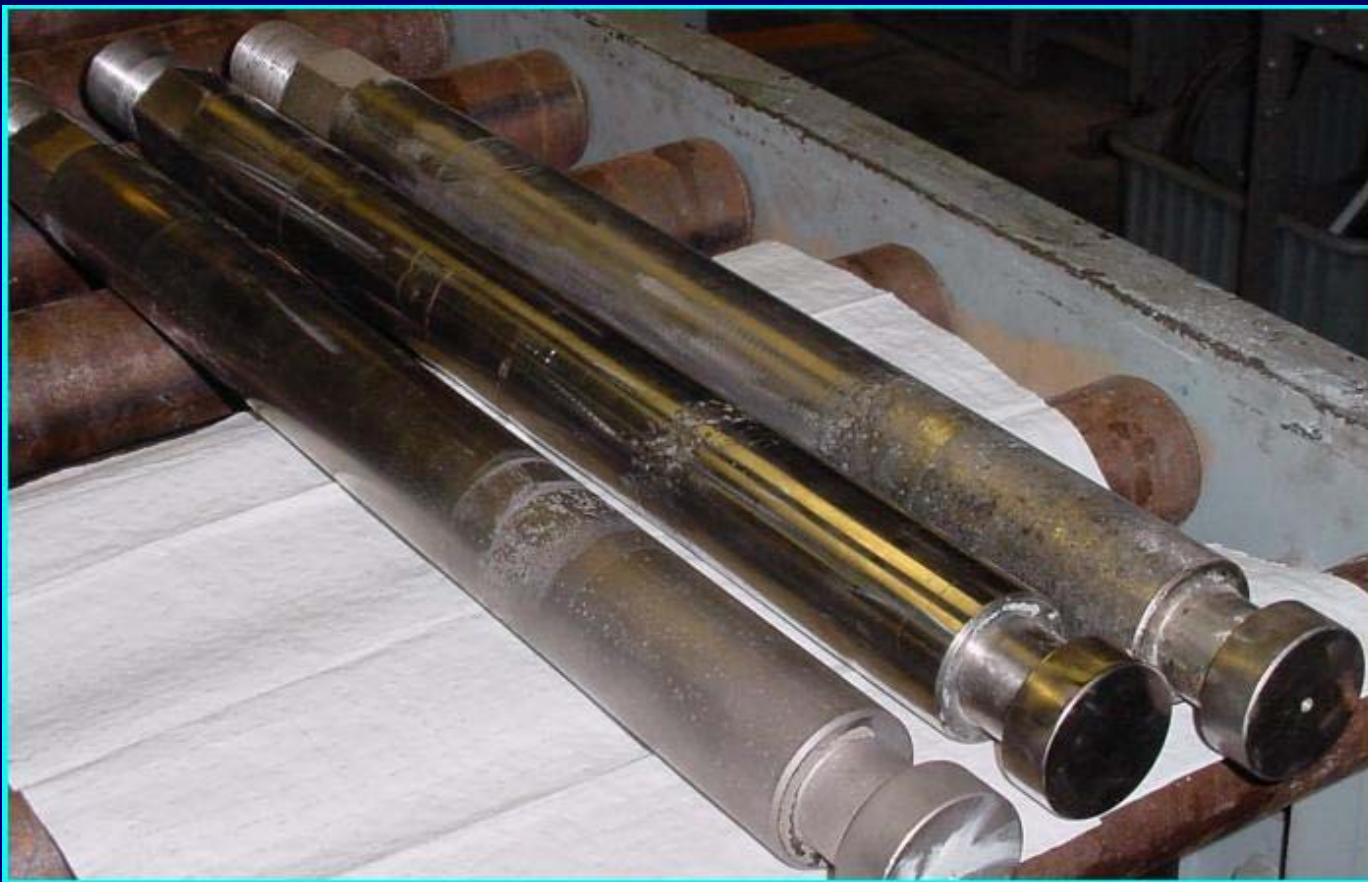
# *Hull Valve Stem*

Unacceptable corrosion/wear of Alloy K500 control rods and valve stems

Electrospark deposition of Alloy 400 to re-establish original dimensions

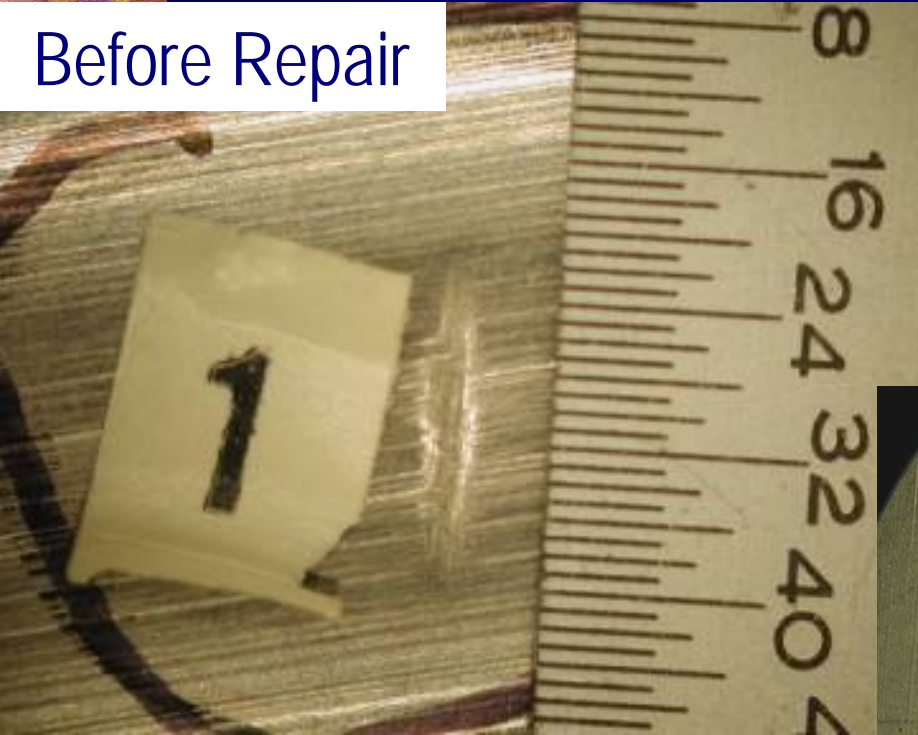
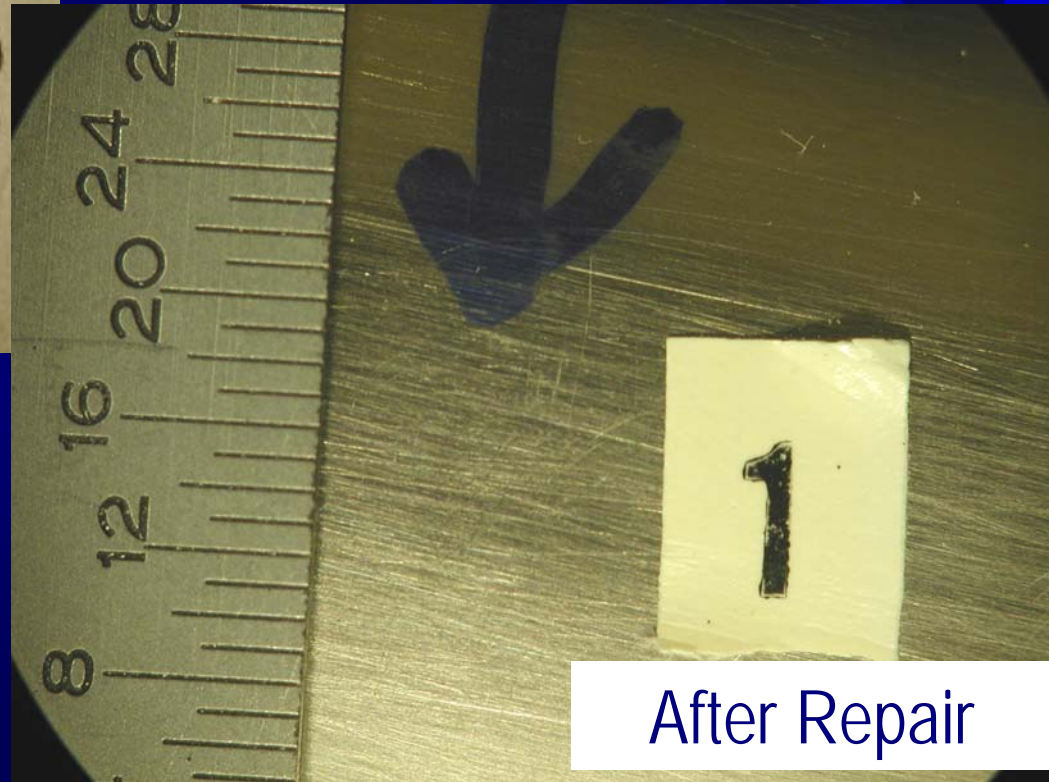
Before Repair

Defect Measured  
0.016" to 0.021" in Depth

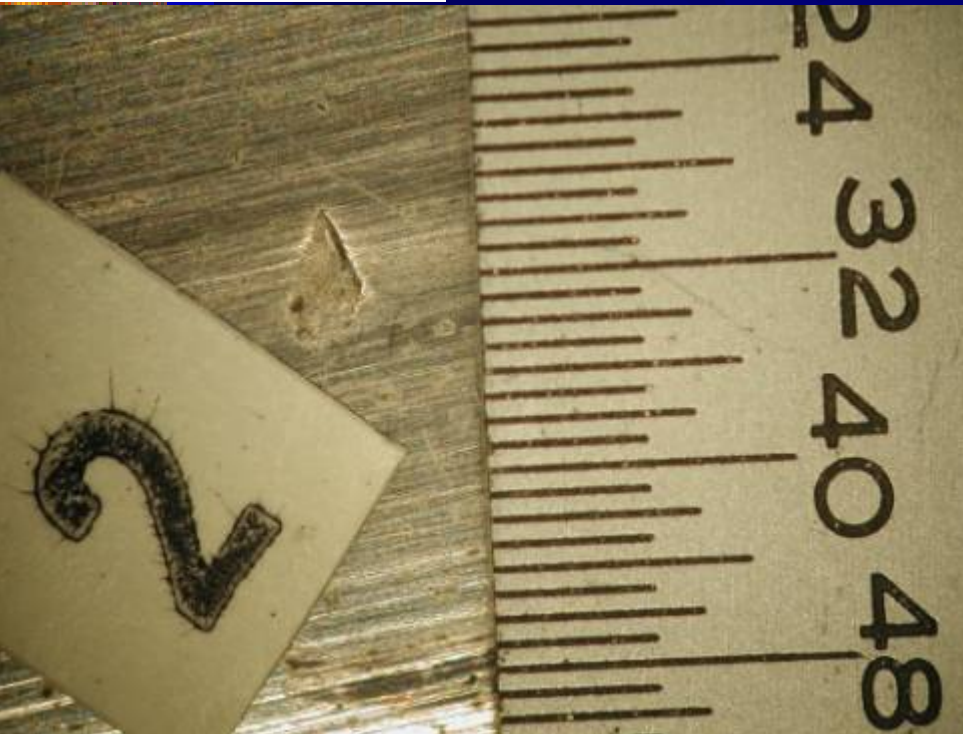
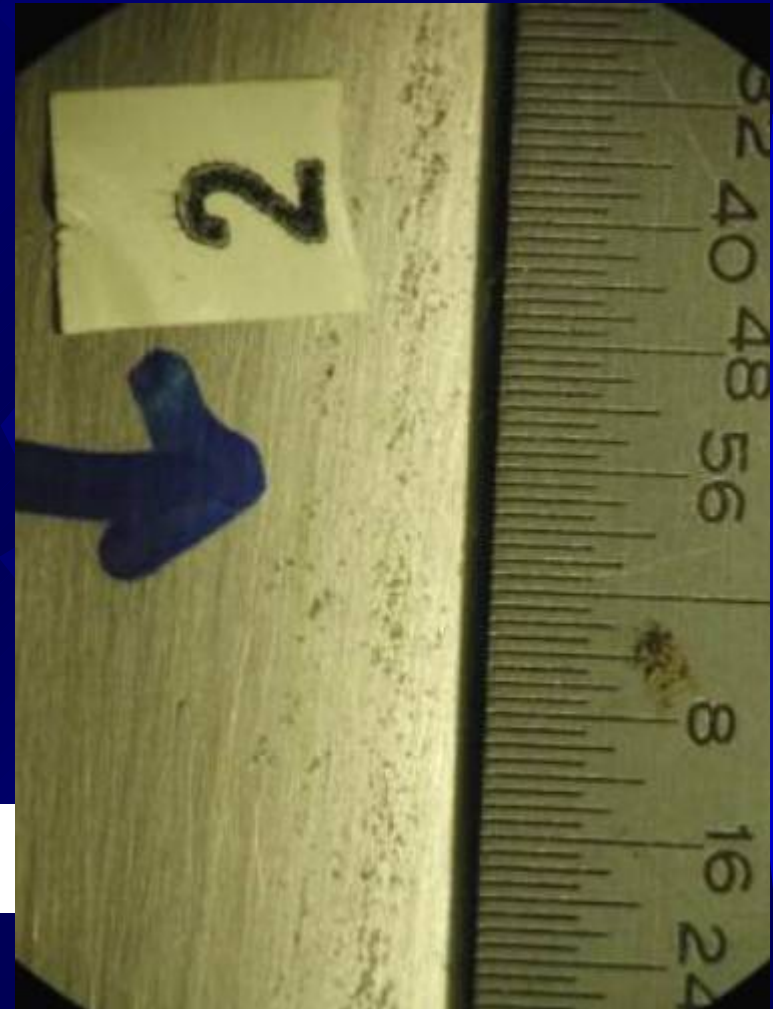
Before Repair

Defect Measured  
0.012" to 0.017" in Depth

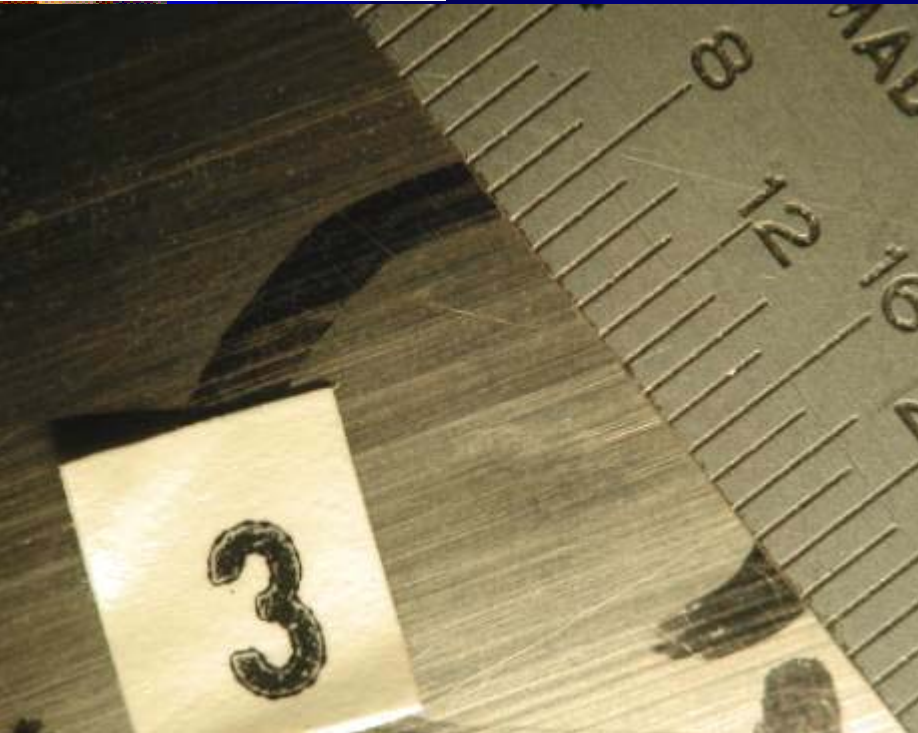
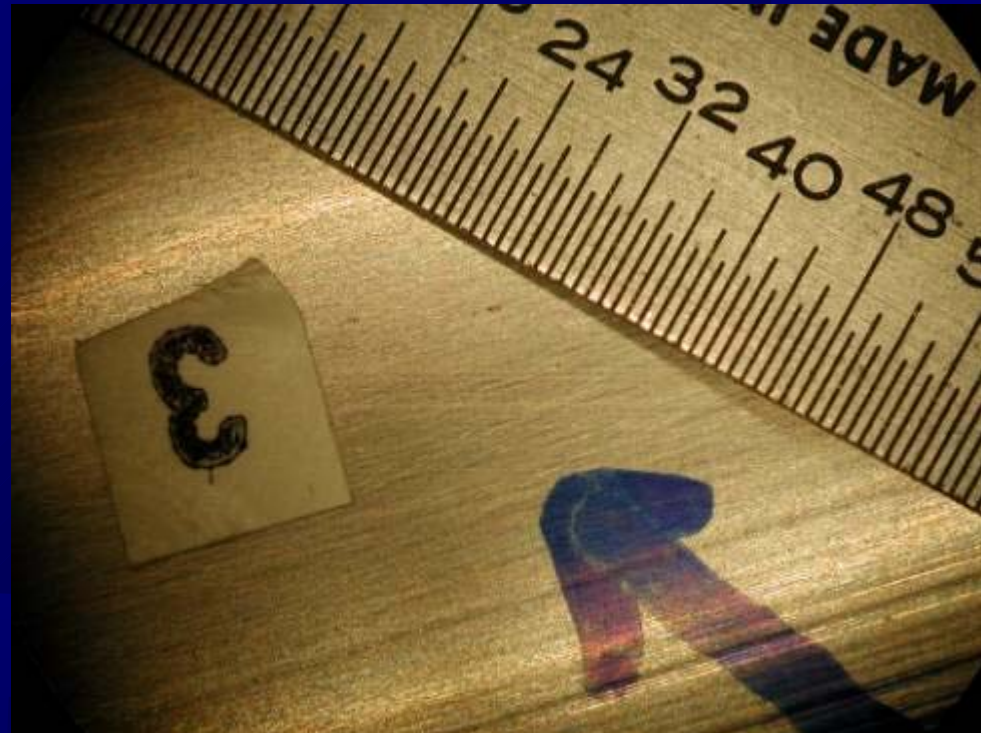
Before Repair

Defect Measured  
0.006" Maximum Depth

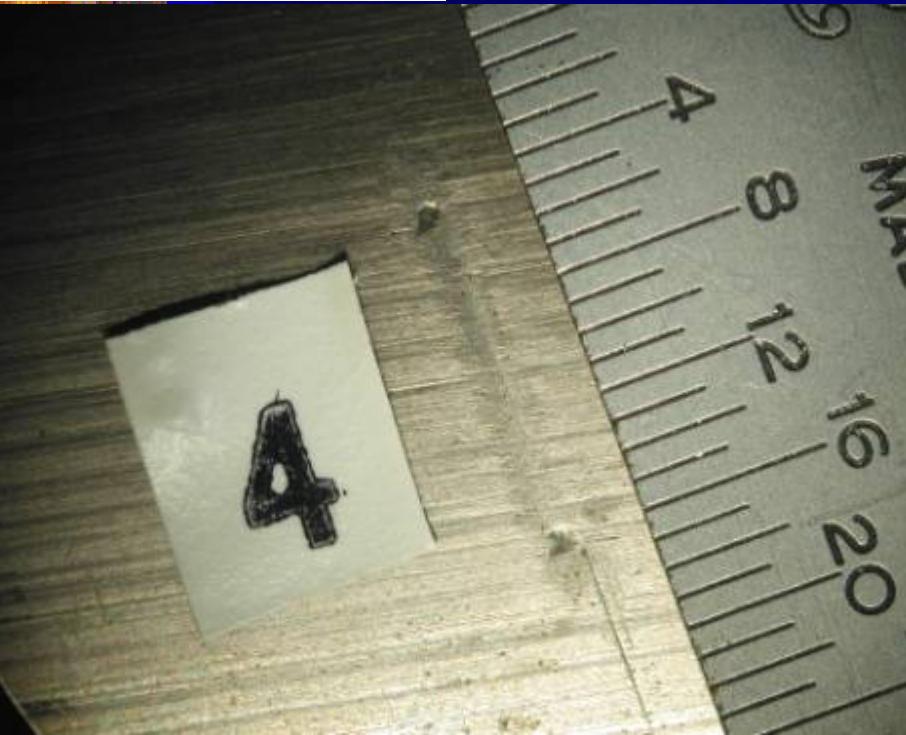
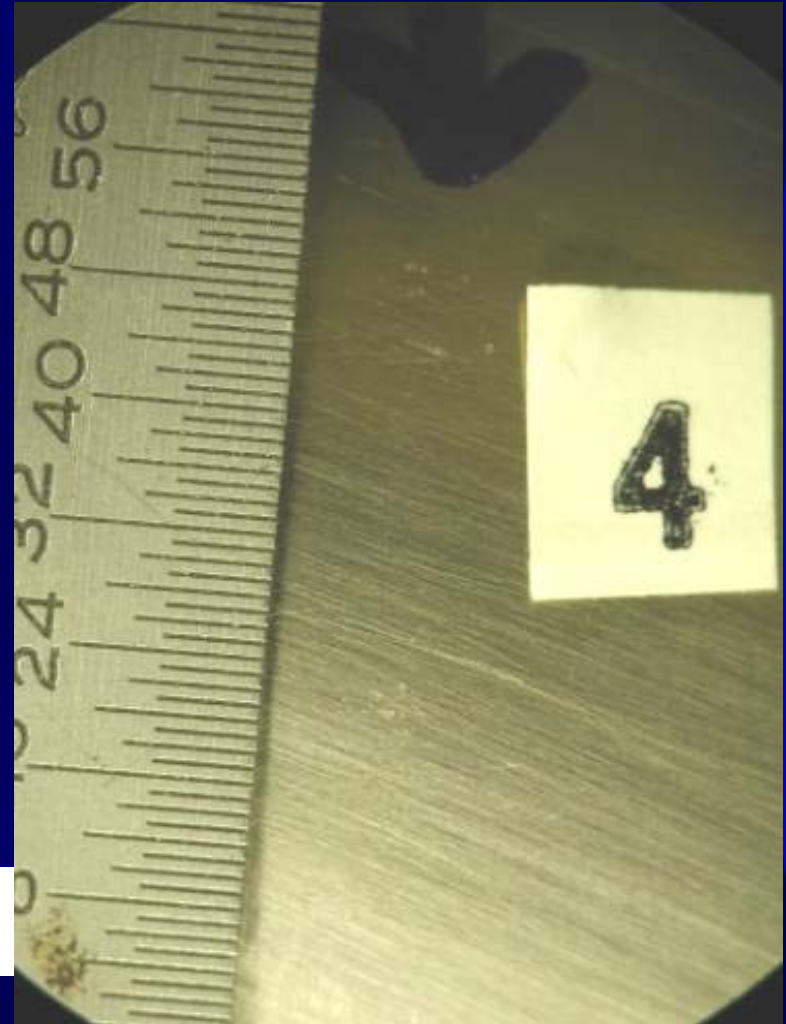
Before Repair

Defect Measured  
0.003" to 0.013" in Depth

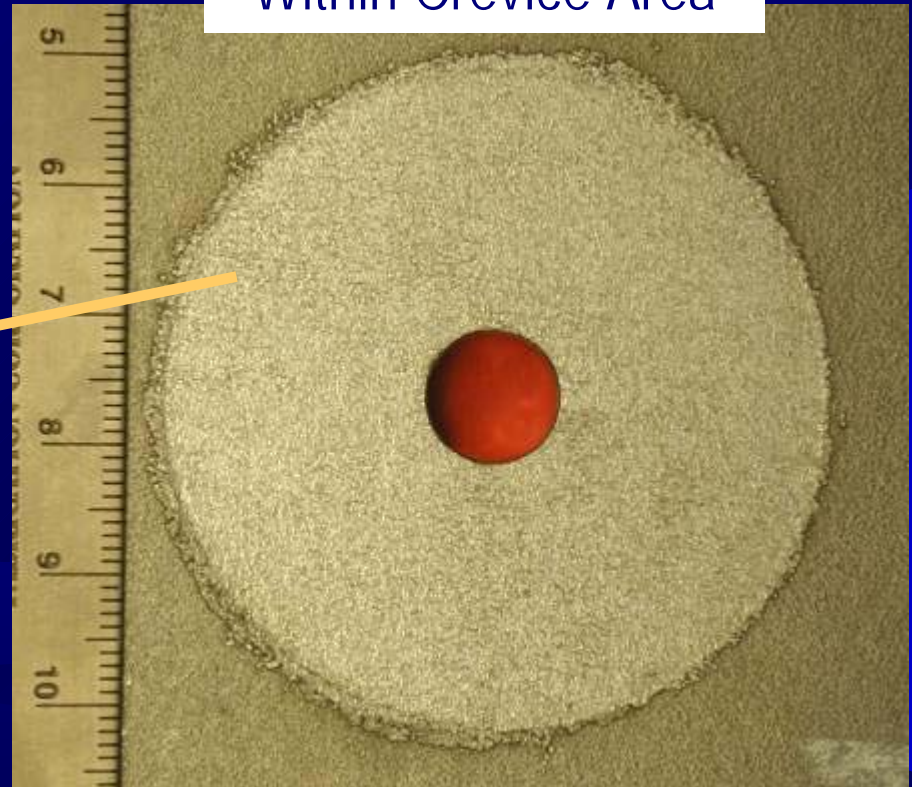
ESD Coating Applied  
Within Crevice Area
